**DAM INSPECTION CHECKLIST
POSSUM POINT POWER STATION
POND ABC**

INSPECTION DATE: 06/20/14

INSPECTED BY: JEFF MARVELL

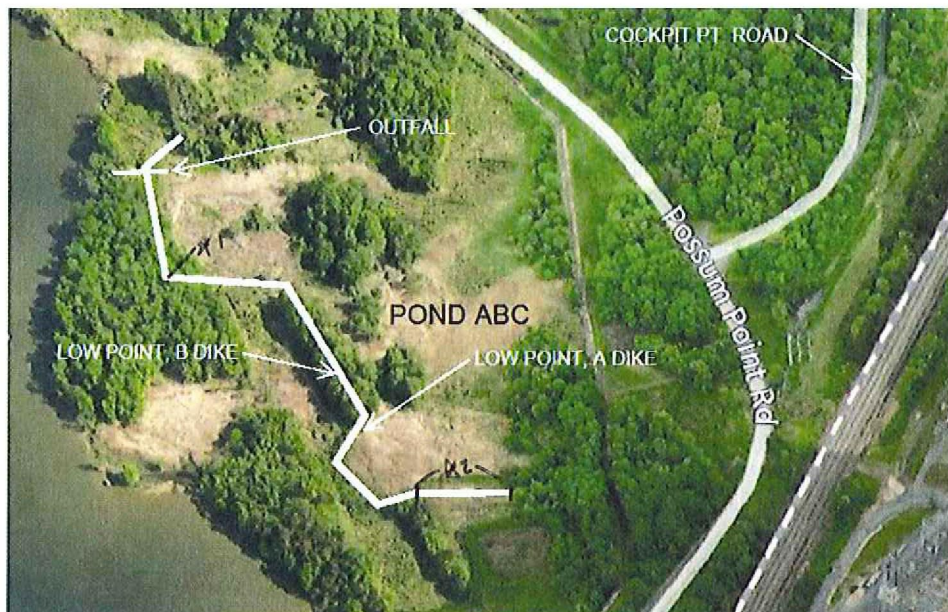
* See figure below.

Location/ Condition	(y/n)	Change (y/n)	Comments
Low Point, A dike*			
Flow	Y	Y	SOME WATER COMING FROM WESTERN SIDE OF DIKE
Erosion	N	N	RIP-RAP IN PLACE NO OBSERVED WATER ANYWHERE ELSE *
Low Point, B dike*			
Flow	N	N	SAND BAGS IN PLACE; NO WATER AT LOW EDGE
Erosion	N	N	DRY
Outfall			
water surface El. (top of stoplogs to water)			38"; VERY LITTLE FLOW (LEAK); FLOW CLEAR (HIGH TIDE)

* - POUNDED WATER AT MIDDLE AND EASTERN EDGE BEHIND BAGS
NO APPARENT BREAKTHROUGH

X1 = POUNDED
WATER
ON ROAD
FROM FERN

X2 = DRY ROAD
